CONNECTICUT RIVER BASIN
CLAREMONT, NEW HAMPSHIRE

FITCH RESERVOIR DAM

PHASE I INSPECTION REPORT
NATIONAL DAM INSPECTION PROGRAM

DECEMBER 1979

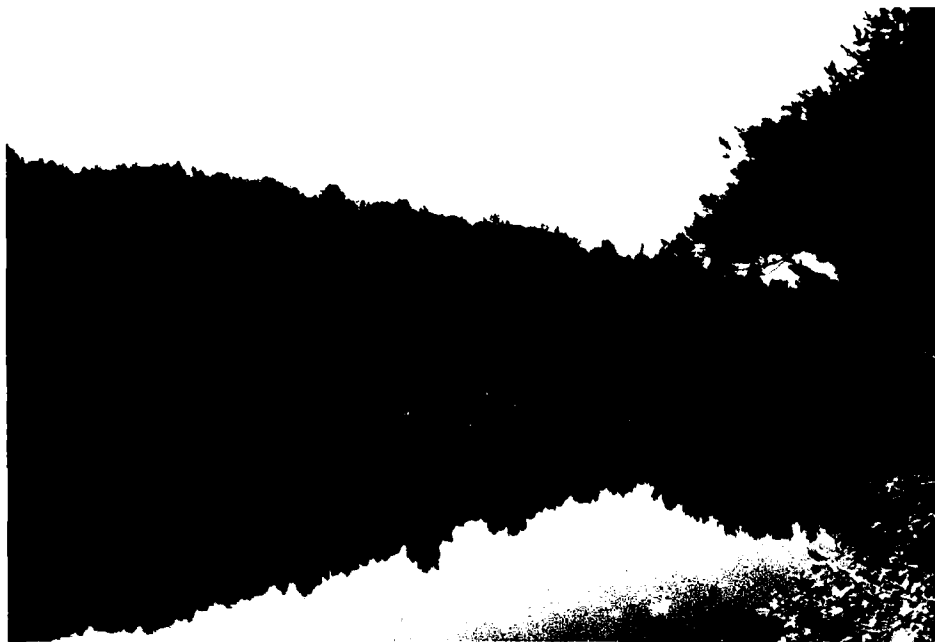
Overview from upstream side

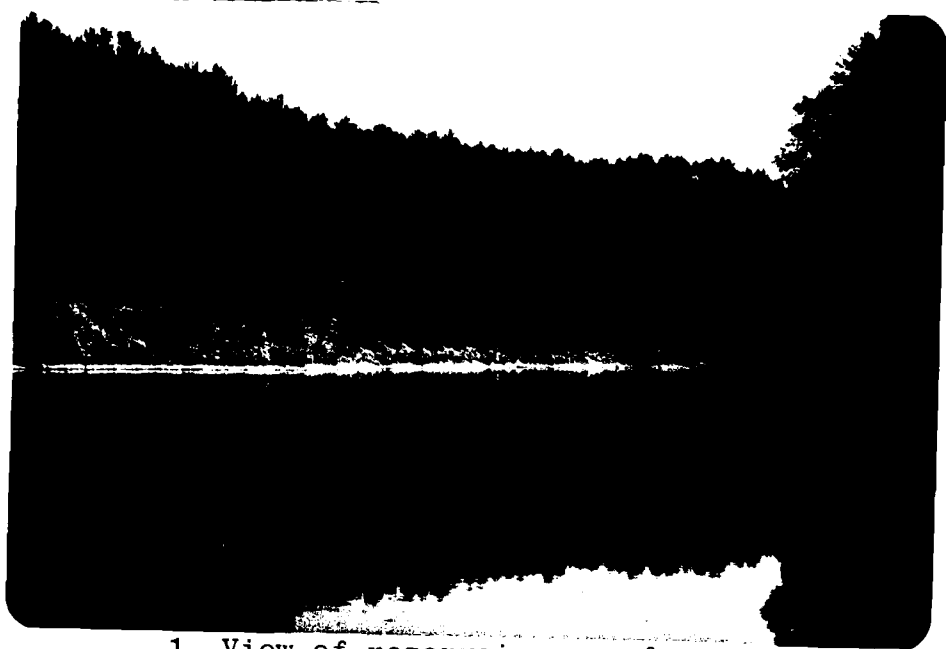
The shore of the reservoir is generally shallow sloping woodland. It appears stable and in good condition with the exception of some minor shallow sloughing approximately 200 feet upstream of the right abutment.

1. View of reservoir area from dam

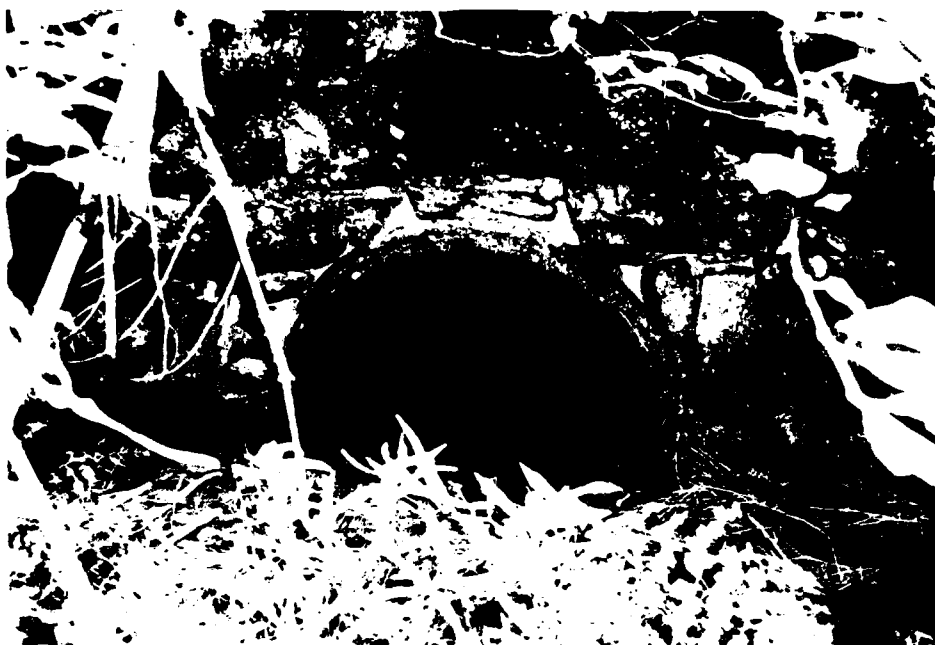
7. Downstream end of 24 inch diameter outlet pipe.
Note siltation to springline

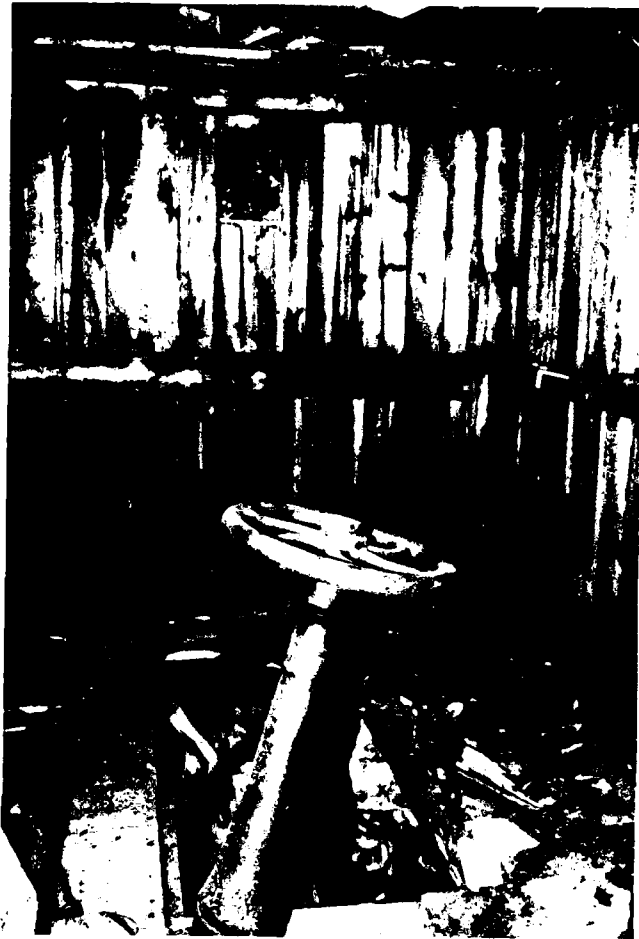
The wood framed gate house is in poor condition with an advanced degree of rot on the wood floor. The wood siding shows evidence of rot. The door of this structure is broken and the structure is prone to vandalism. The gearing system attached to the bench stand, for operating the 24-inch gate, is completely rusted. It is doubtful that this gate can be operated without complete rehabilitation. Discussions with personnel of the Claremont Water Works revealed that this gate has not been operated in the past five years and possibly once in the preceeding ten years. The 8-inch gate valve is operable and at the present time is partially opened. The rate of discharge at the time of inspection was 2 to 3 g.p.m.

9. Interior of gate house
